Cart-Style Extendo

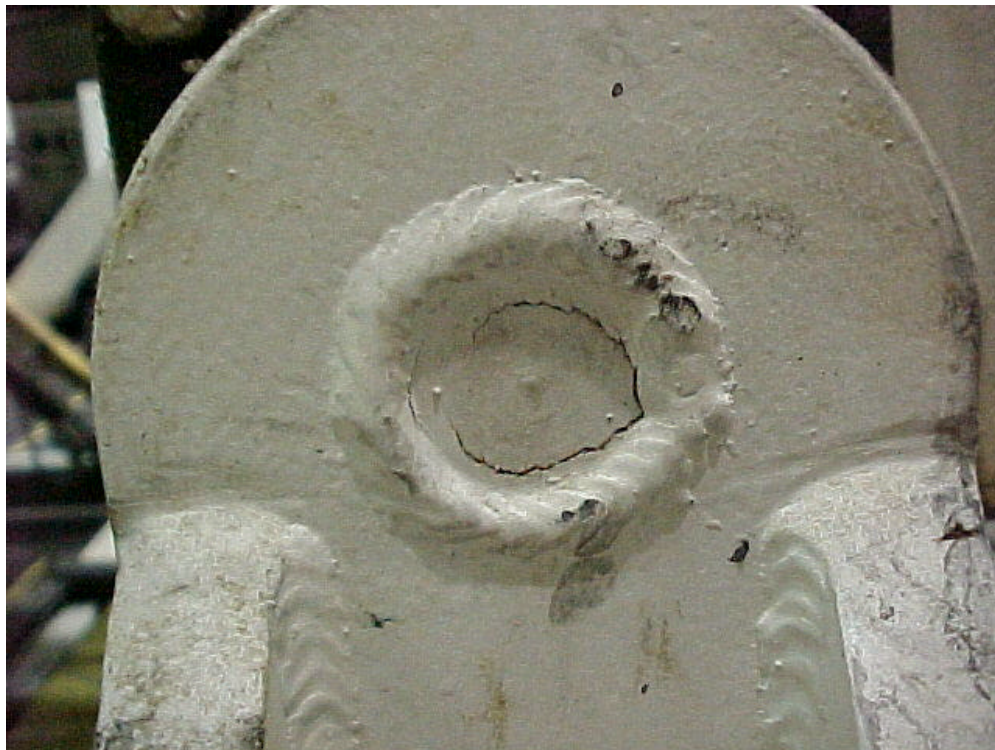
Crack Located in the Shaft
